MLD Home Inspections

Home Inspection

Property address: **169-60**

Inspection date: **Wednesday, May 30, 2018**

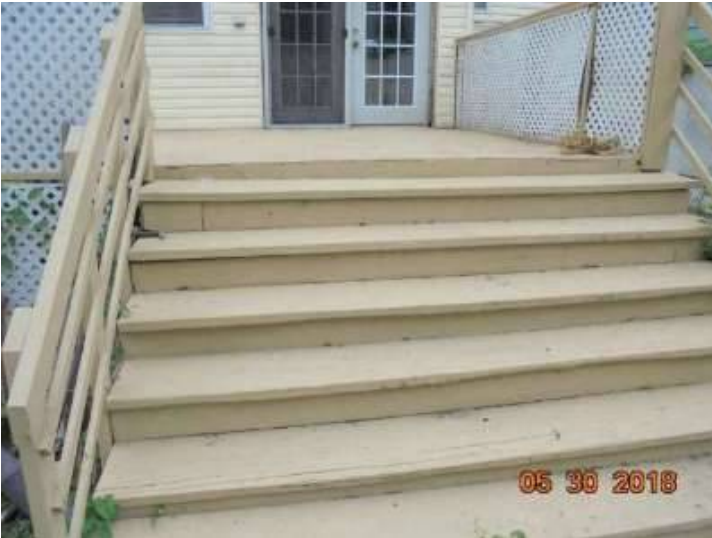
Photo 1-1

Risers for stairs at rear of the house were less than 7 3/4 inches and posed a fall or trip hazard. Risers should be 7 3/4 inches or shorter. At a minimum, be aware of this hazard, especially when guests who are not familiar with the stairs are present. Check with the local building code for height guidelines. Recommend that a qualified contractor repair per standard building practices.

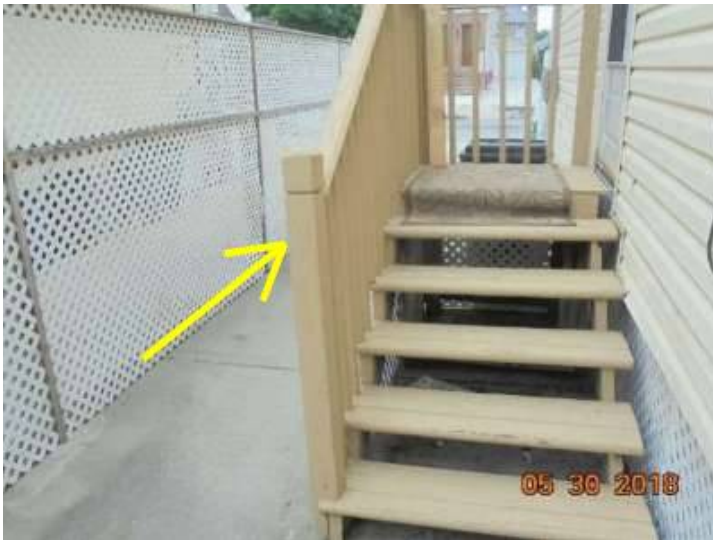
Photo 2-1

Handrails at one or more flights of stairs were wobbly. This is a safety hazard. Recommend that a qualified person repair as necessary.

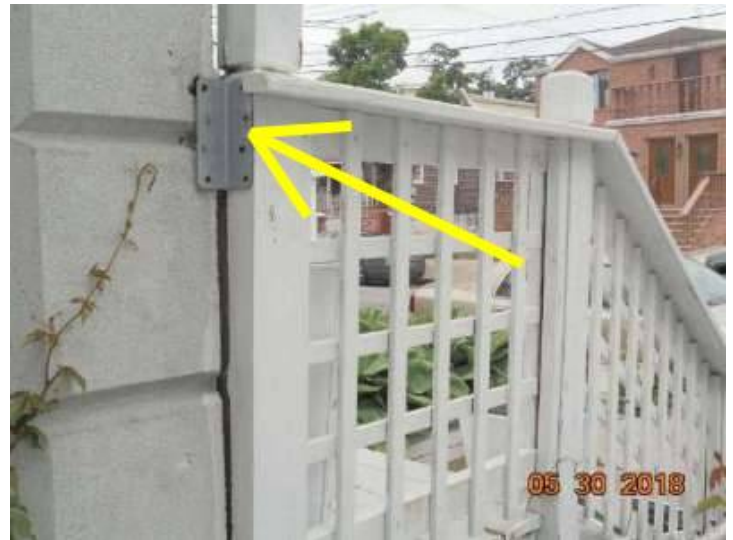
Photo 2-2
Loose bracket

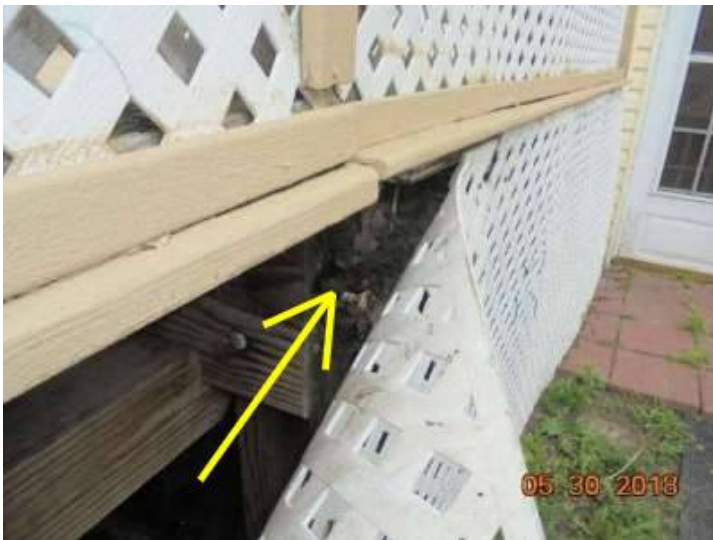
Photo 3-1

Fungal rot was found in joists at the rear deck. Recommend that a qualified contractor evaluate and repair as necessary. All rotten wood should be replaced.

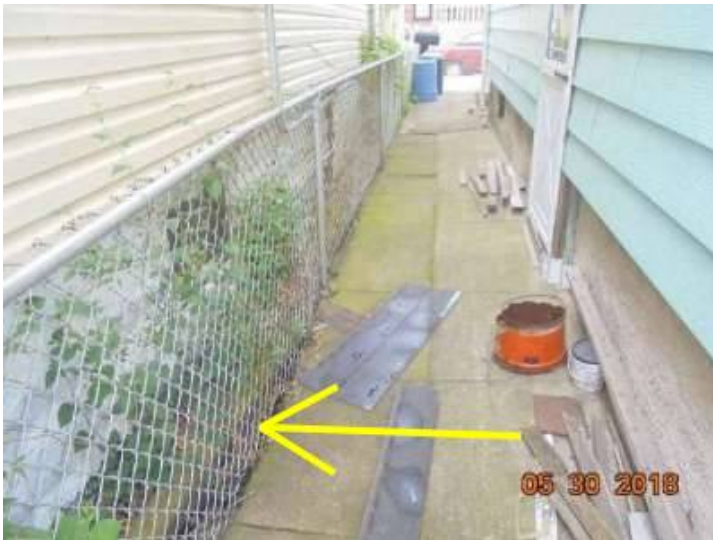
Photo 5-1

The soil or grading sloped down towards building perimeters in one or more areas. This can result in water accumulating around building foundations or underneath buildings. It can be a conducive condition for wood-destroying organisms. Recommend grading soil so it slopes down and away from buildings with a slope of at least 1 inch per horizontal foot for at least 6 feet out from buildings.

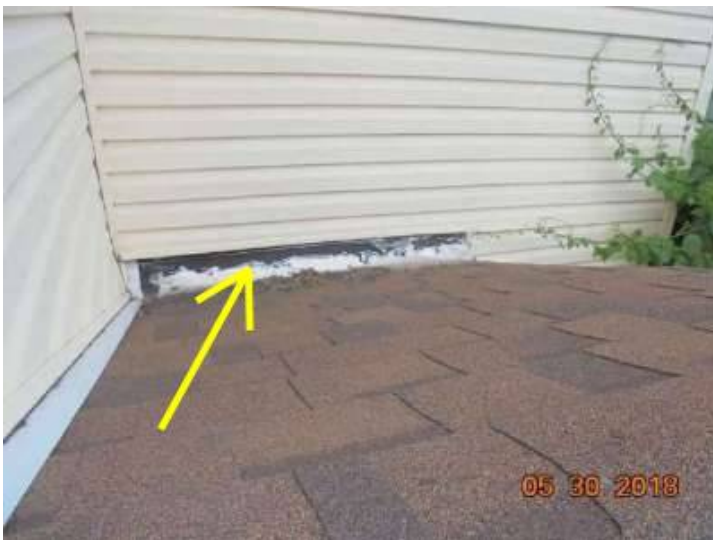
Photo 6-1

The metal flashing above the tool shed is deteriorated and is pitched the wrong way. Water appear to be accumulating when it rains. Recommend that a contractor install new metal flashing so that water drains away from the roof.

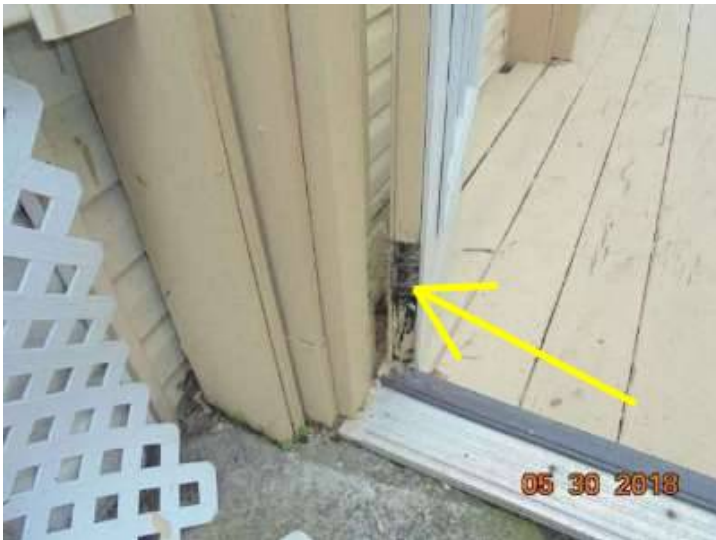
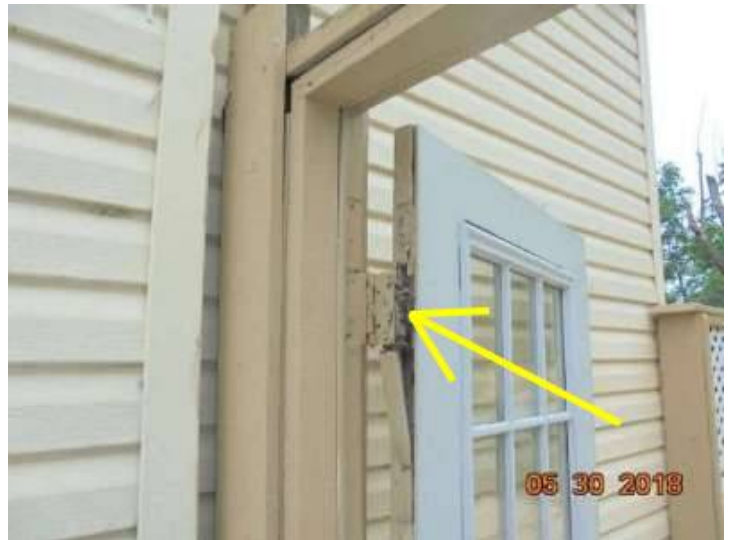
The exterior door to the back yard has deteriorated beyond repair, recommend replacing the door.

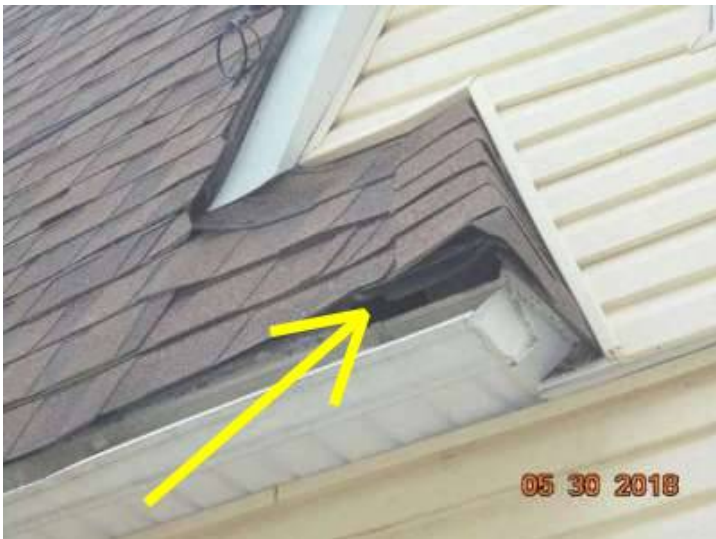
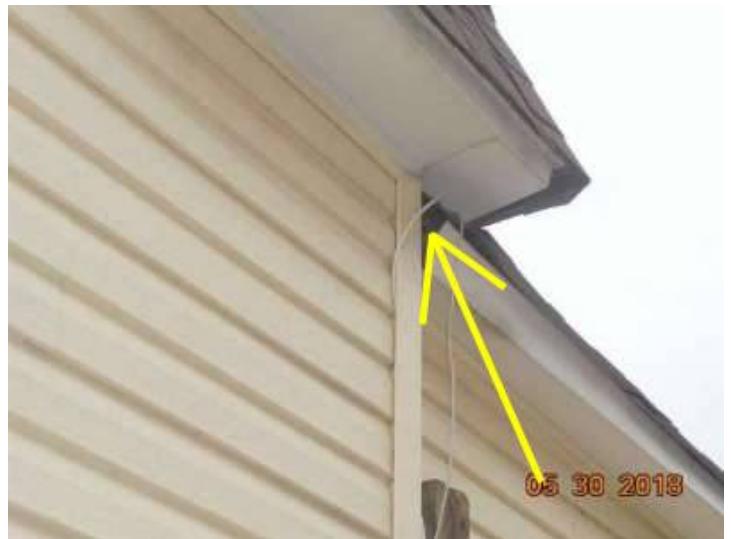
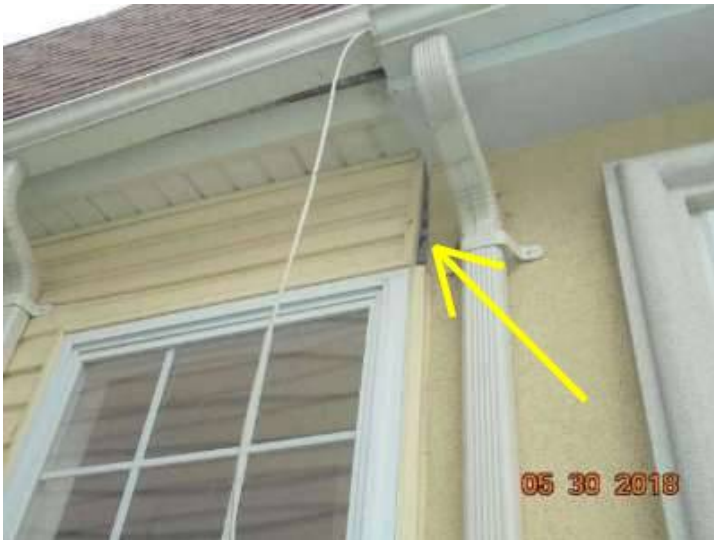
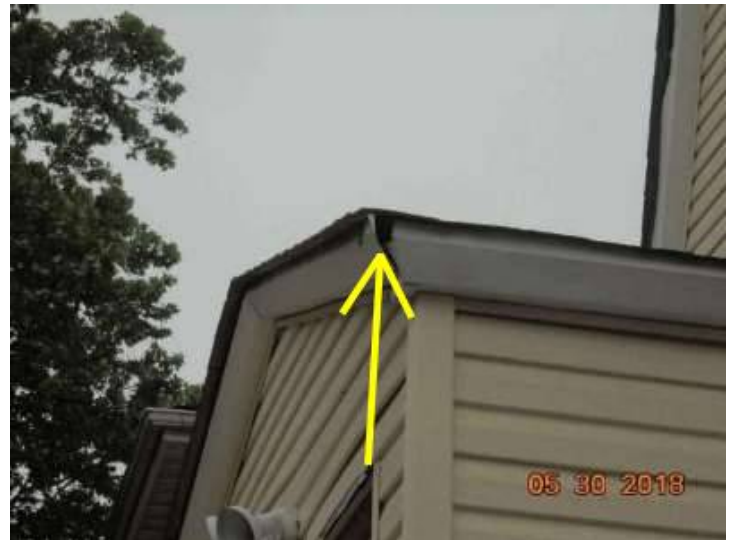
Some sections of siding and/or trim were missing, detached and/or substandard. Recommend that a qualified person repair, replace or install siding or trim as necessary.
Cost estimate: \$ 450

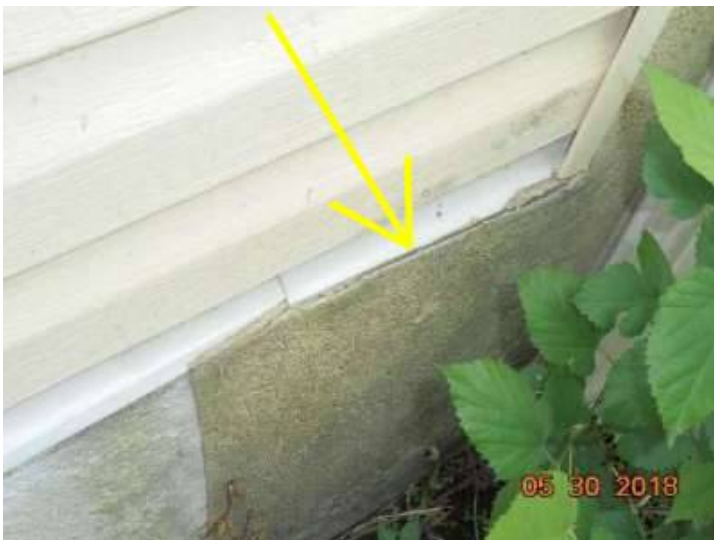
Photo 10-1

10) The stucco on the east side of the house is cracked and hallow, this section should be repair so that water does not infiltrate between the stucco and the wall. Consult with a qualified contractor to make repairs.

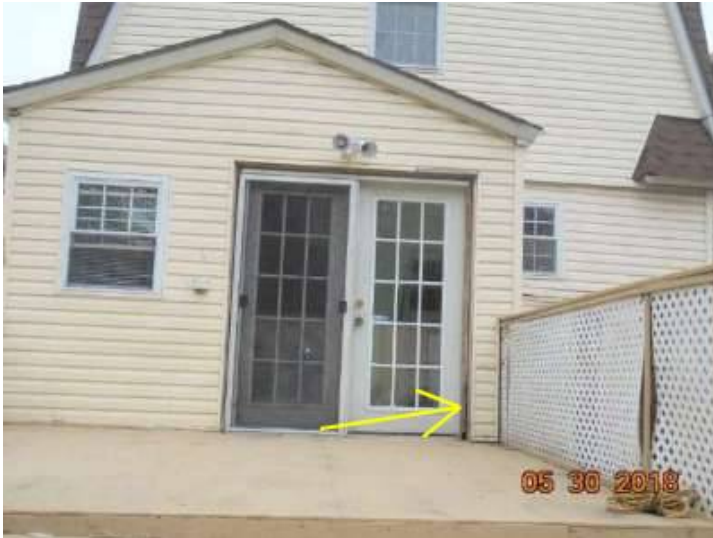
Photo 11-1

11) Rear door frame was exposed and it showed signs of water damage. Have a qualified contractor install aluminum trim as required.

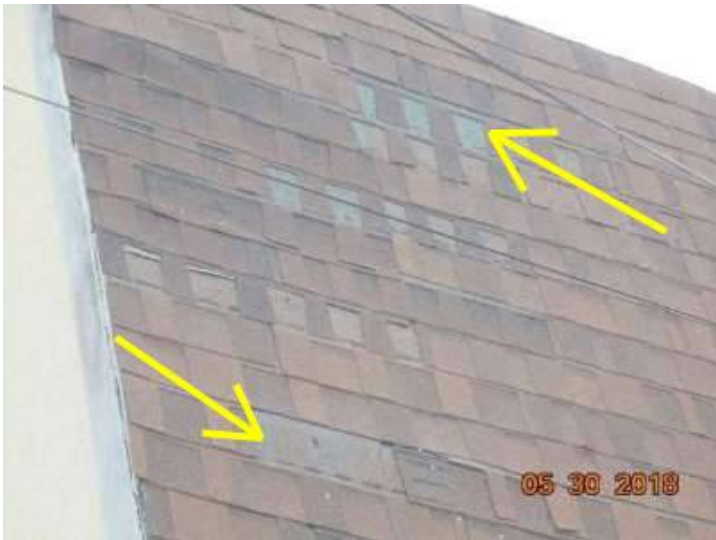
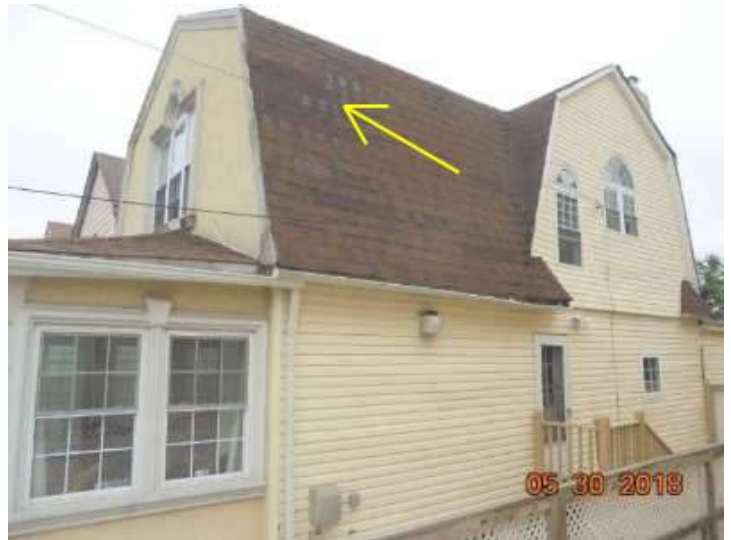
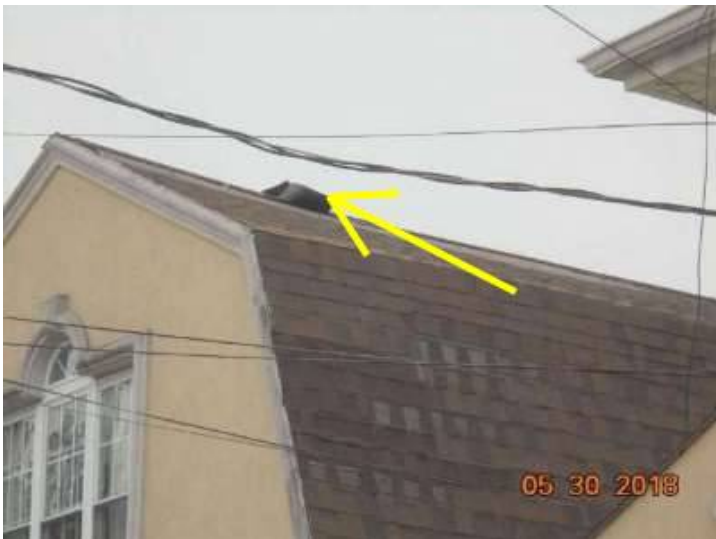
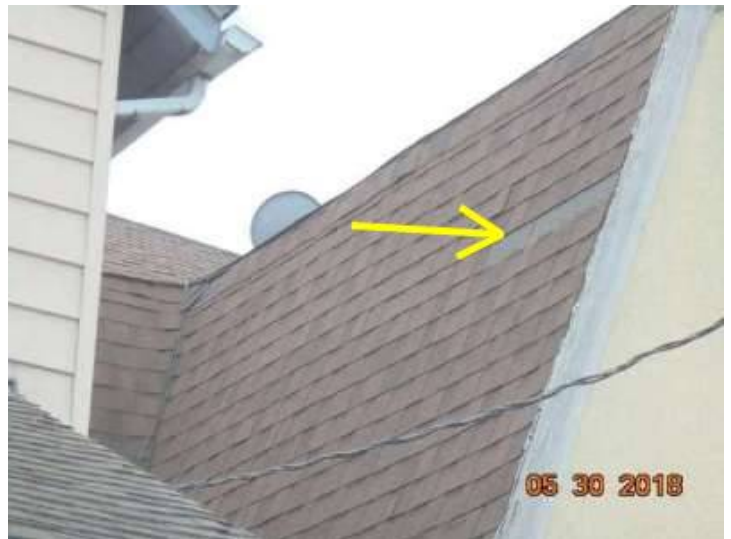
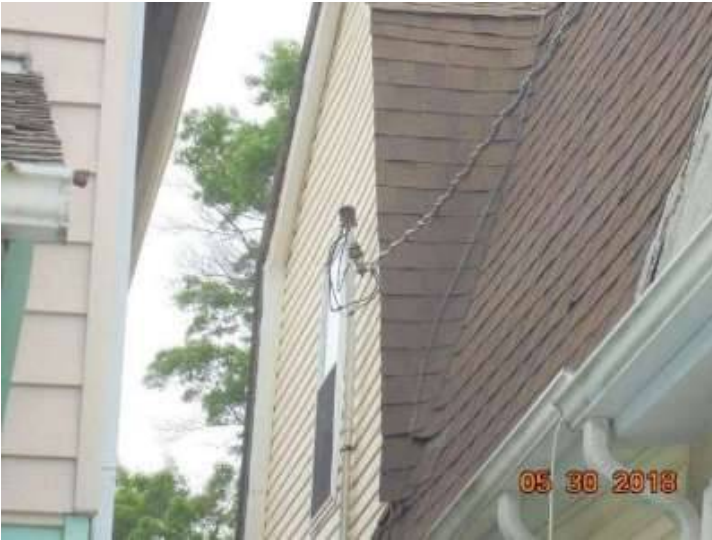
Substandard repairs were found at one or more locations on the roof surface. Such as nails showing, loose shingles, missing shingles, and over extended roof shingles in some sections. Leaks can occur as a result. This is a conducive condition for wood-destroying organisms. Recommend that a qualified contractor replace the entire roof to ensure a proper installation.

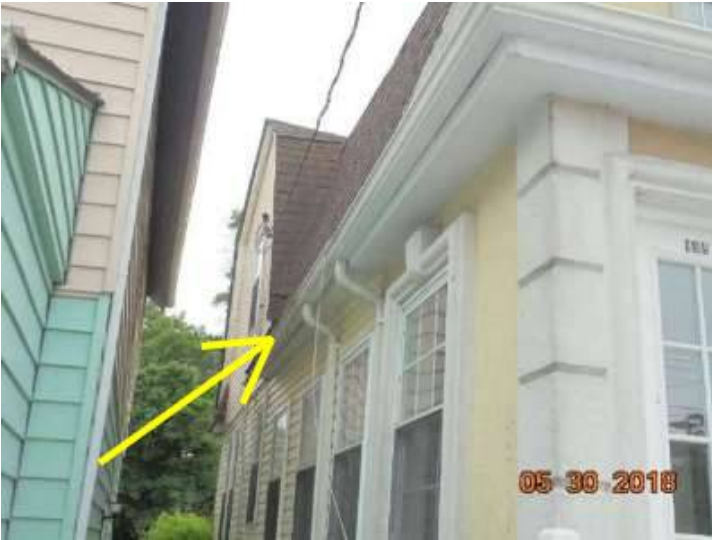
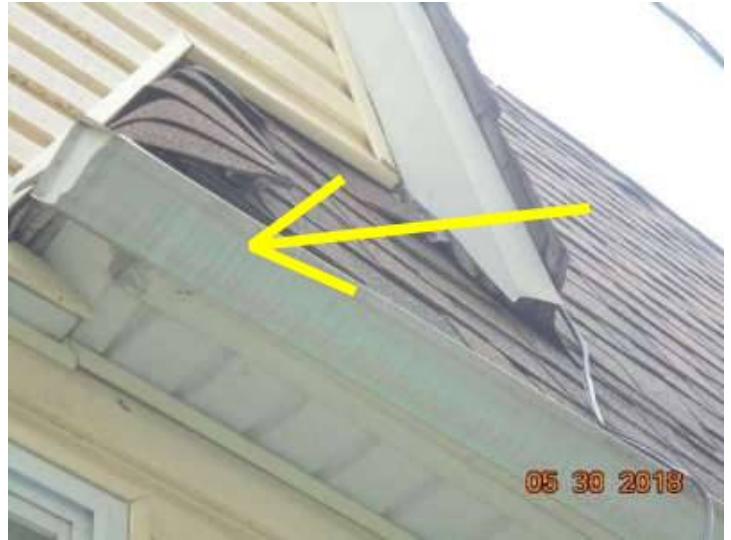
One or more gutters had a substandard slope so that significant amounts of water accumulate in them rather than draining through the downspouts. This can cause gutters to overflow, especially when debris such as leaves or needles has accumulated in them. Rainwater can come in contact with the building exterior or accumulate around the foundation as a result. This is a conducive condition for wood-destroying organisms. Recommend that a qualified person repair as necessary. For example, by correcting the slope in gutters or installing additional downspouts and extensions.

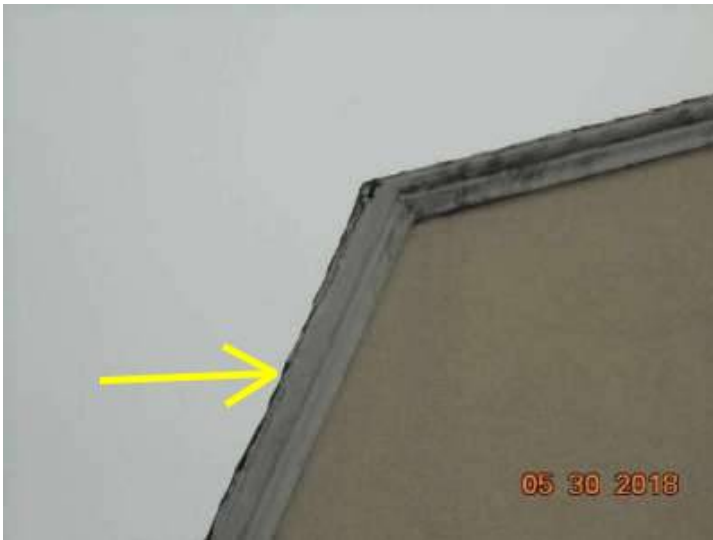
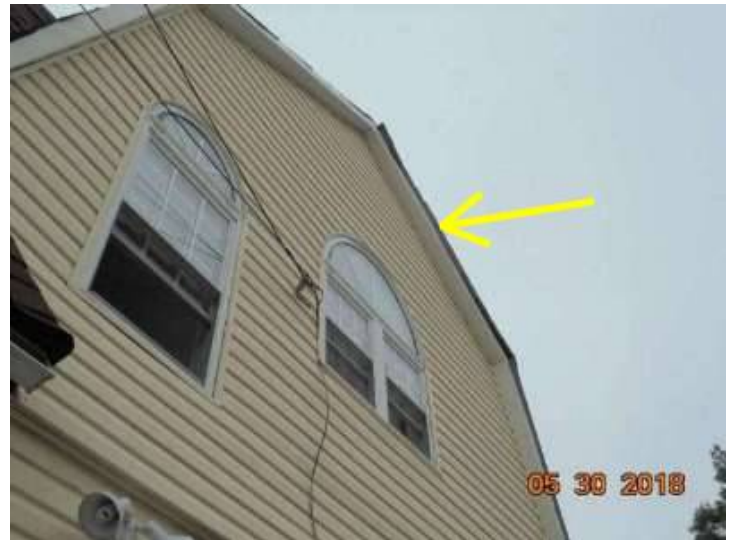
No "drip edge" flashing was visible at roof eaves (lower edges) or rakes (gable end edges). Drip edge helps prevent water from soaking into the edges of the roof sheathing material (typically plywood or oriented strand board). This reduces the chance of fungal rot or deterioration from water damage in the roof sheathing. Recommend that a qualified contractor install drip edge flashings where missing and per standard building practices.

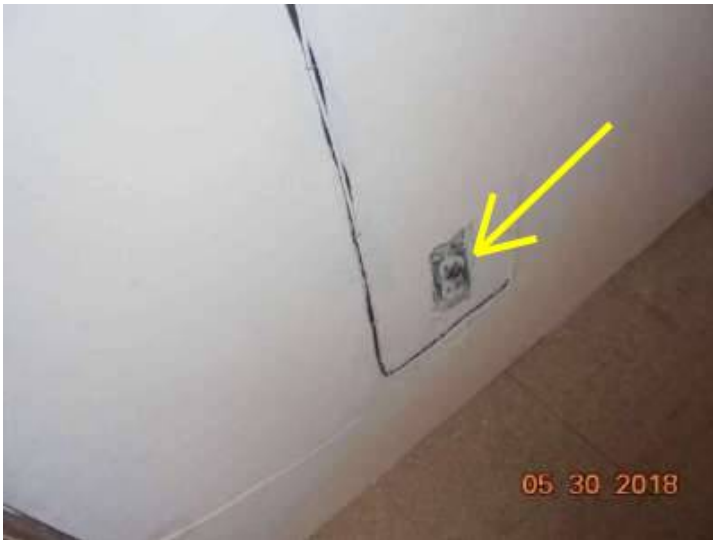
**Photo 17-1**

One receptacles under the basement stairs was scorched. The wiring for this receptacles may be damaged due to overheating. Recommend that a qualified electrician replace such receptacles, evaluate related wiring and repair if necessary.

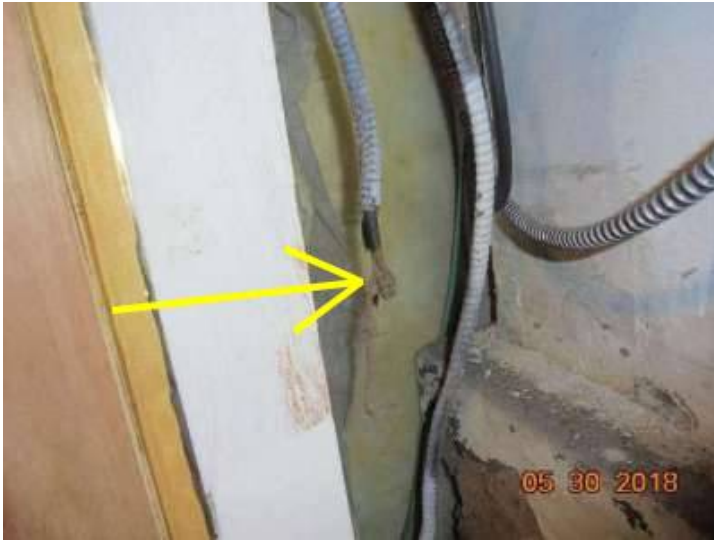
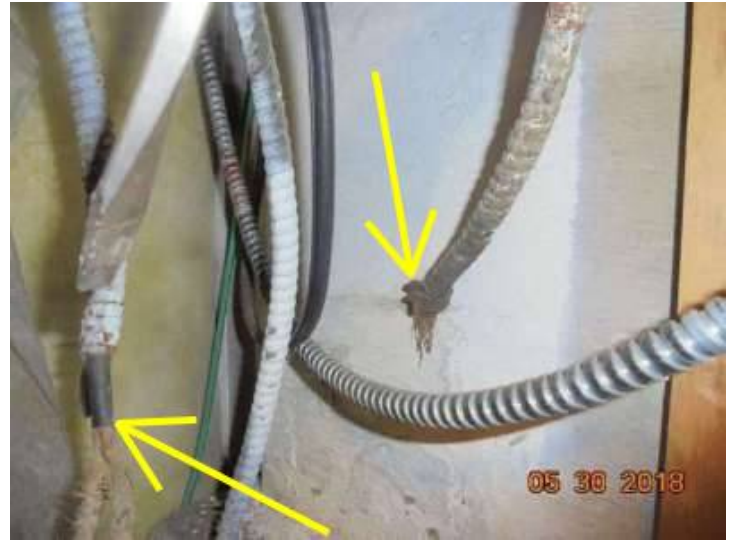
Several exposed electrical wires were noted around the main panel in the basement. This is a safety hazard if the wires are energized. They did not appear to be energized at the time of the inspection, however they should be removed or at a minimum they should be properly capped off or placed in junction boxes. Consult with a license electrician to make repairs.

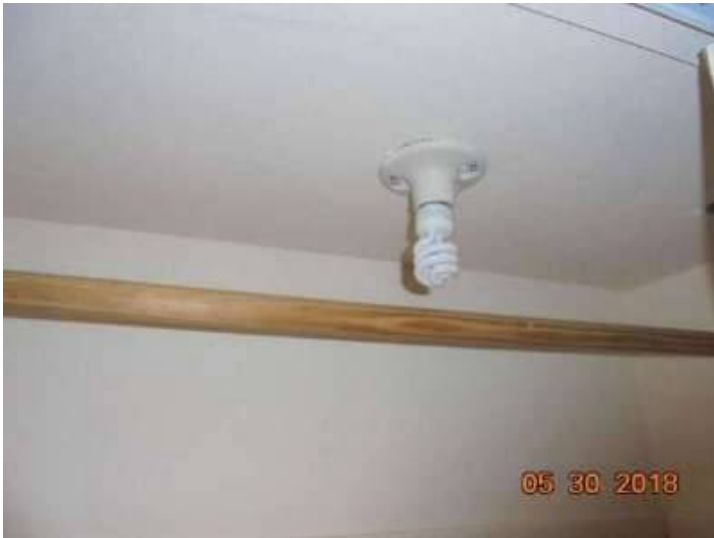
Photo 20-1

One or more globes or covers for light fixtures were missing in several closets. Recommend replacing as necessary to avoid exposed bulbs. With closet lighting or where flammable stored objects are near light fixtures, missing or broken covers can be a fire hazard.

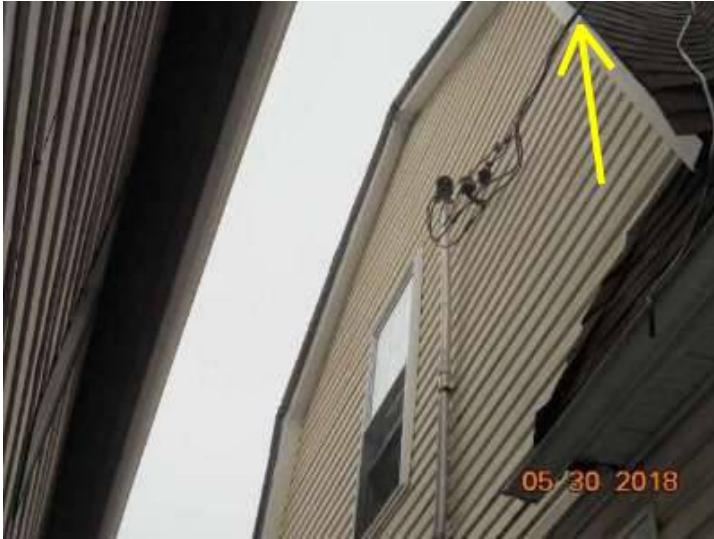
Photo 23-1

The service drop wires were in contact with the roof edge. This can result in damage to wiring insulation or broken wires

during high winds. Recommend that an electrician evaluate and create a clearance between the roof edge and the cable as necessary. The utility company may do this at no charge.

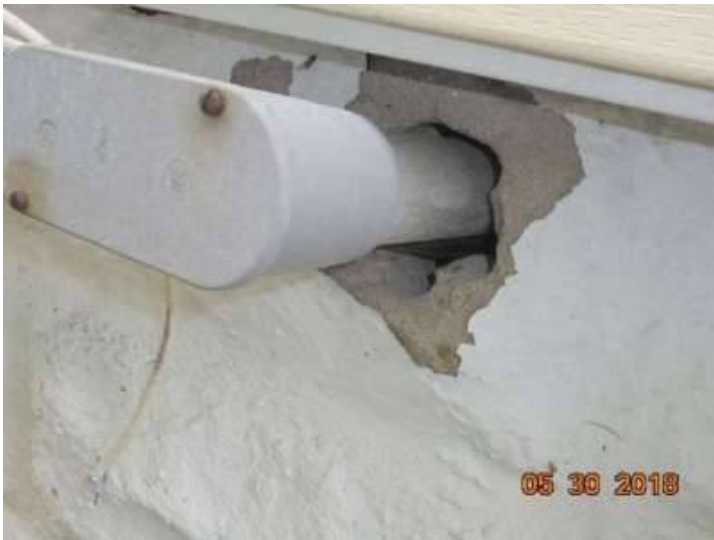
Photo 24-1

24) 🛠️🔑 The main service entrance conduit was not sealed, as a result vermin and water can enter the house and into the electrical box. Recommend sealing this entry point with silicone or foam.

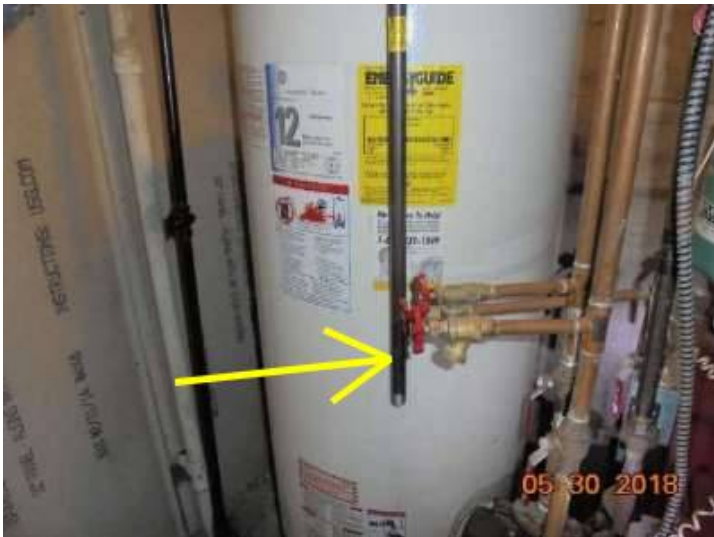
Photo 26-1

The temperature-pressure relief valve drain line was too short. This is a potential safety hazard due to the risk of scalding if someone is standing next to the water heater when the valve opens. Recommend that a qualified plumber repair per standard building practices. For example, by extending the drain line to within 6 inches of the floor, or routing it to drain outside. For more information, visit:

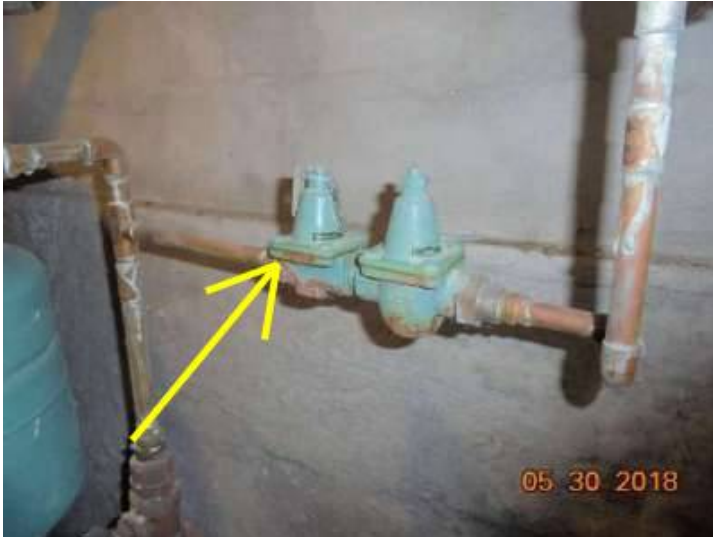
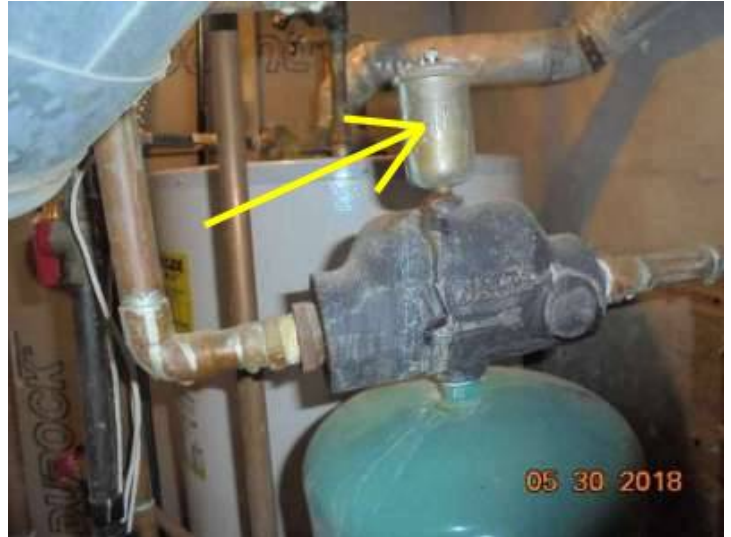
27) + Two pressure release valves were leaking at the time of the inspection. This is a concern, these valve may not work properly if the pressure builds up. Consult with a license plumber to replace all defective valves.

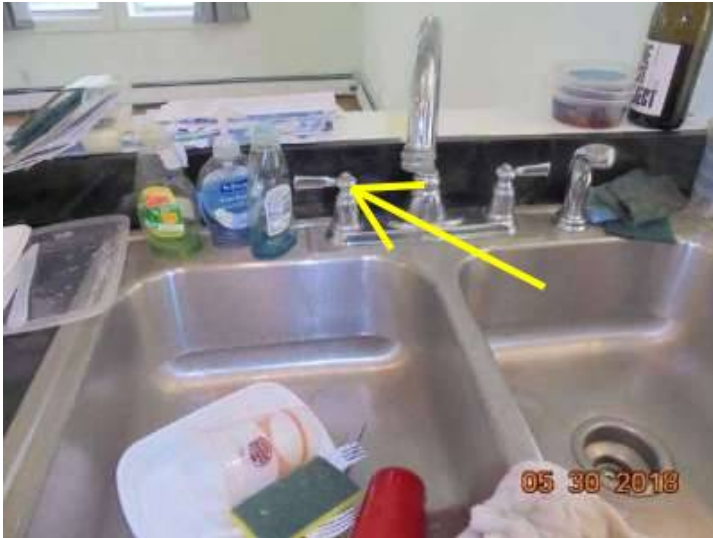
Photo 28-1

28) Kitchen sink faucet was not closing all the way, water was dripping. Have a qualified contractor replace the hot water faucet.

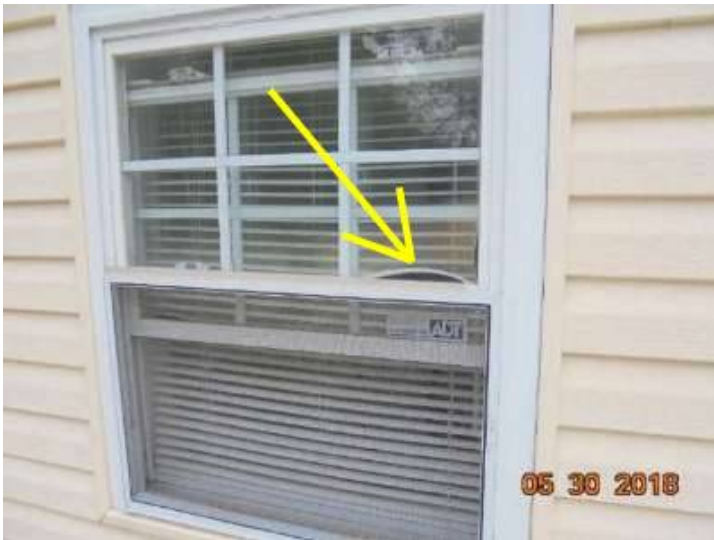
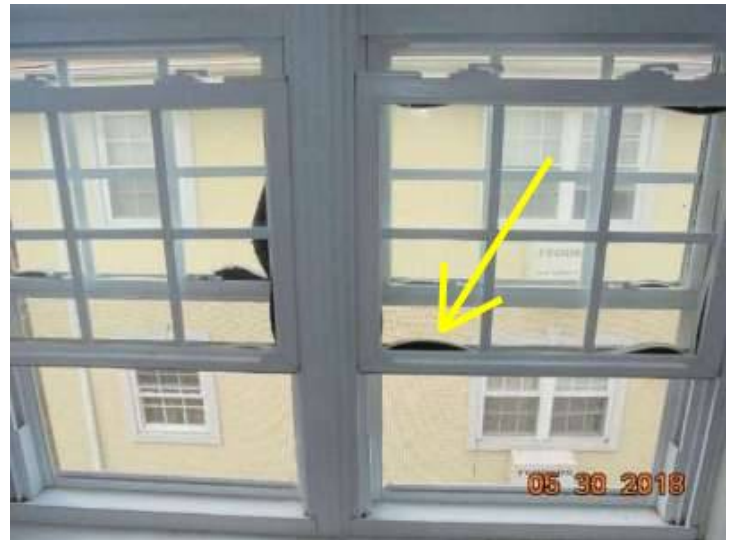
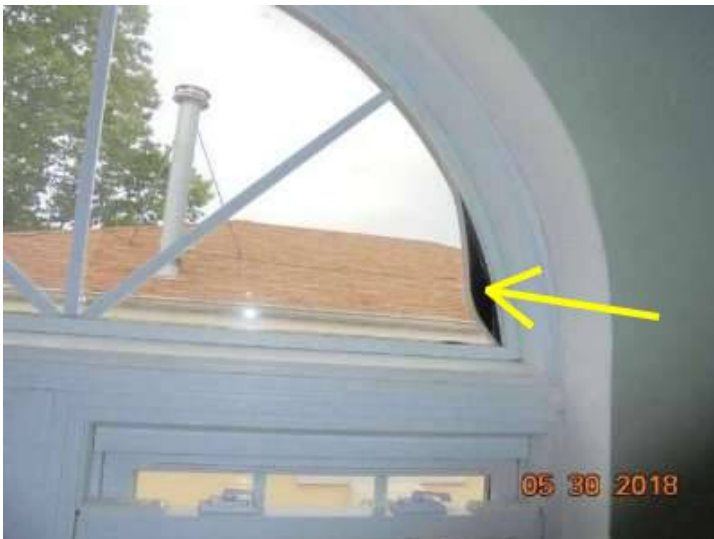
The Hermetic seals in several windows have failed. These rubber-like seals are prone to failure with age and heat. Recommend replacing the sashes to prevent lose of heat during the winter.

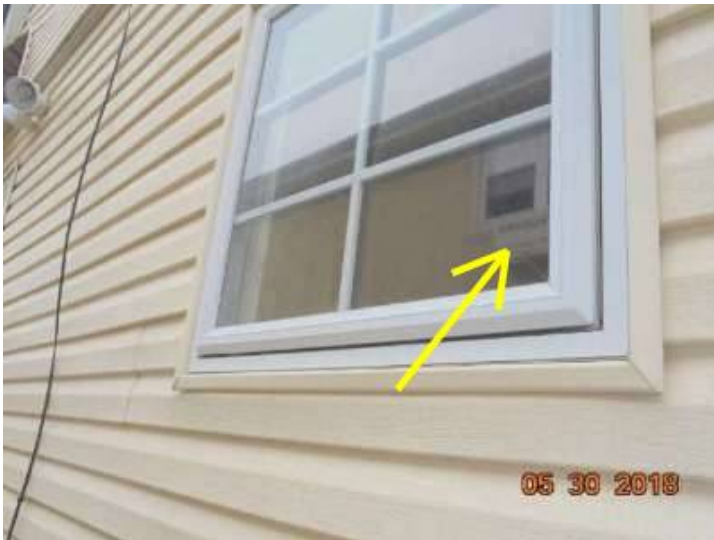
Photo 32-1

32) Window in the kitchen was cracked. Have a qualified contractor to replace the sash.
Cost estimate: \$ 250

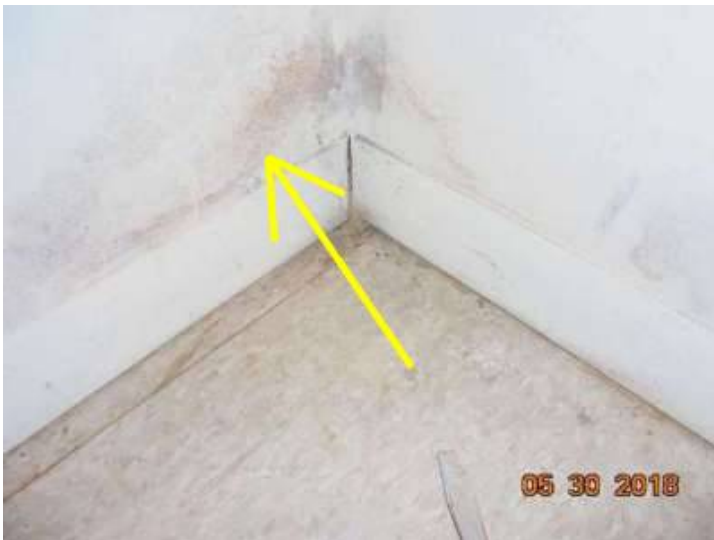
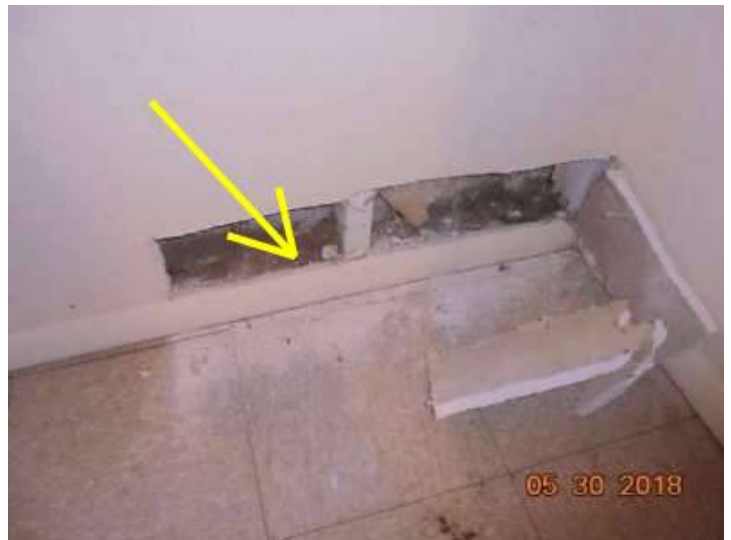
33) Past termite damage was noted at the bottom sill plate. (See report attached)
