MLD Home Inspections

Home Inspection

Property address: 7 Lester Ave

Inspection date: Sunday, August 5, 2018

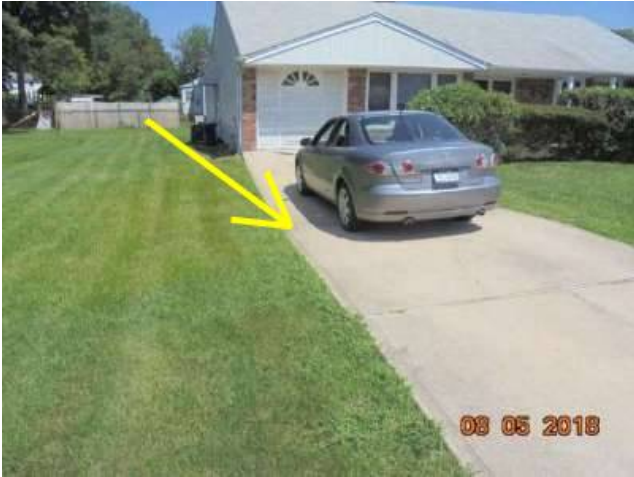
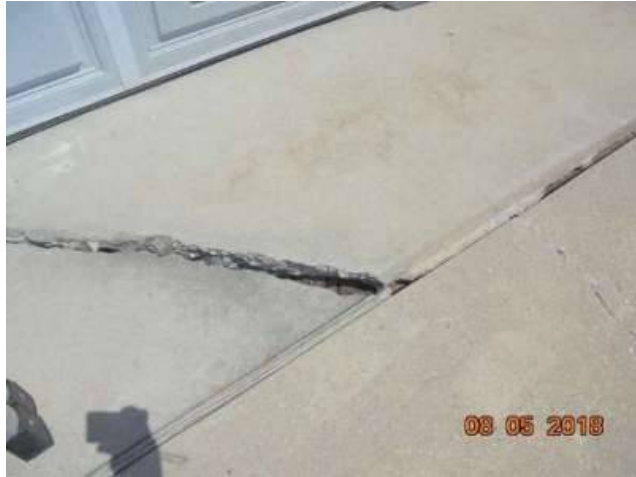
Major Concern - Cracks, settlement, heaving and/or deterioration resulting in trip hazards and structural concerns were found in the driveway. For safety reasons, recommend that a qualified contractor repair as necessary.

Cost estimate: \$11,500.00

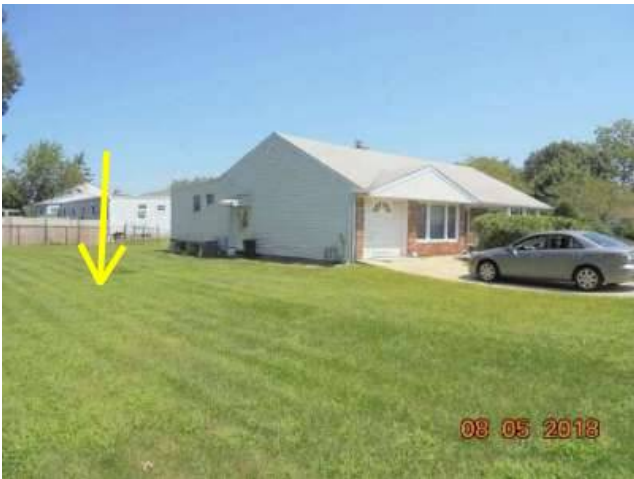
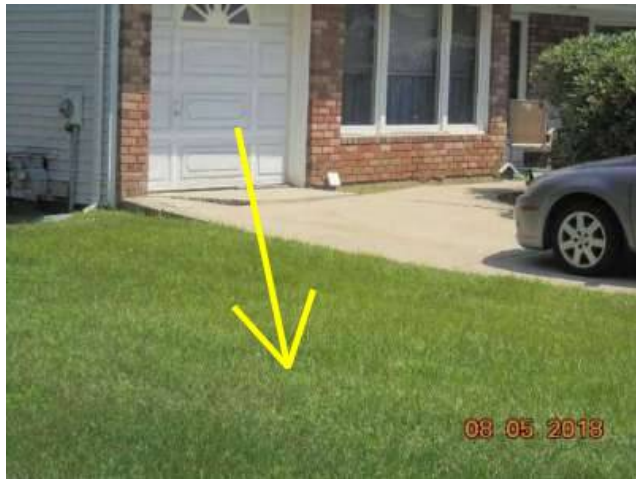
Major Concern - Several sections of the side yard have sunken and appears that the driveway has settled to the point where the driveway has become a tripping hazard. Consult with a qualified contractor to investigate the cause of the depressions and fix as recommended.

Cost estimate: \$3,600

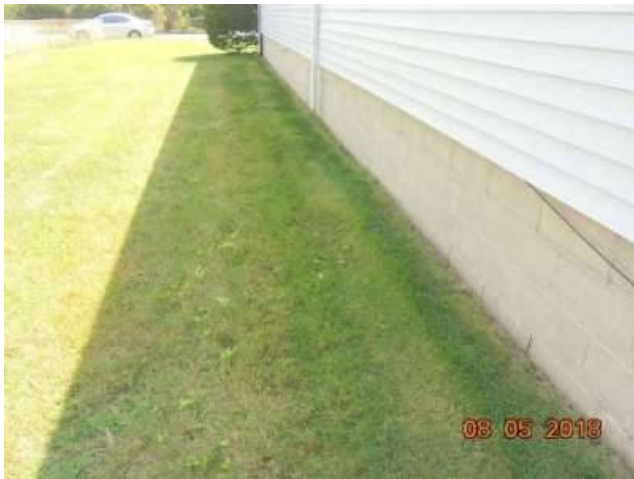
The soil or grading sloped down towards building perimeters in one or more areas. This can result in water accumulating around building foundations or underneath buildings. It can be a conducive condition for wood-destroying organisms. Recommend grading soil so it slopes down and away from buildings with a slope of at least 1 inch per horizontal foot for at least 6 feet out from buildings.

Photo 3-1 Back of house

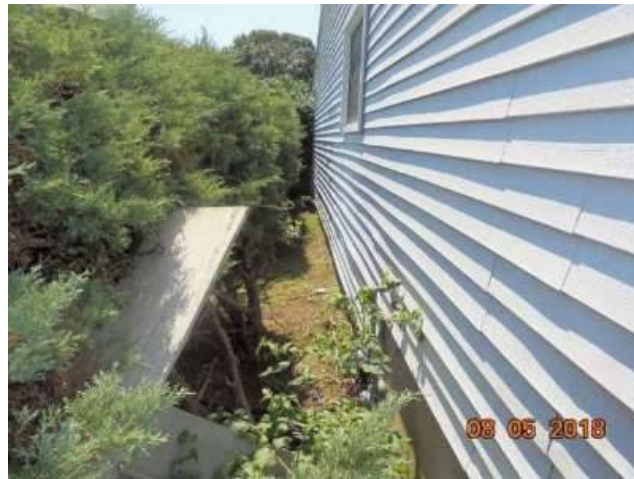
Photo 3-2 East side of house

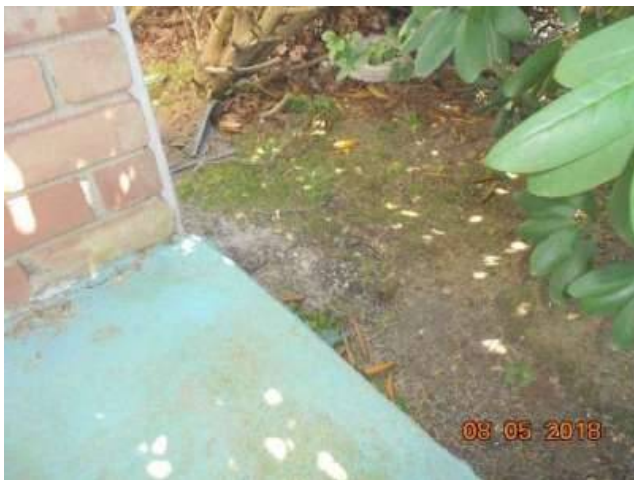
Photo 3-3 East side near the front

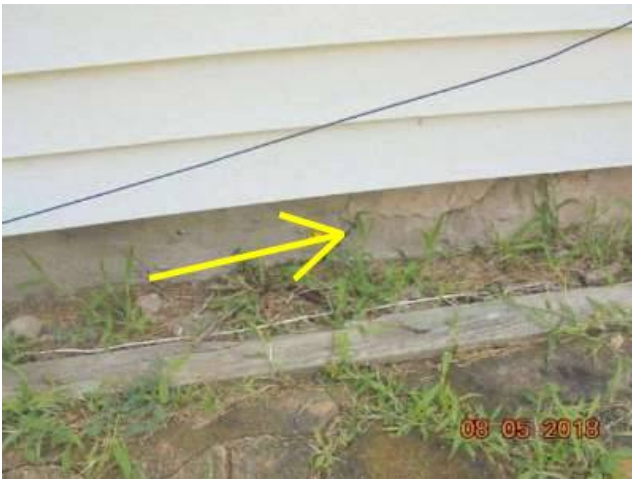
Photo 5-1

One or more minor cracks (1/8 inch or less) were found in the foundation. These didn't appear to be a structural concern, but recommend sealing them to prevent water infiltration and monitor them in the future. Numerous products exist to seal such cracks including hydraulic cement, non-shrinking grout, resilient caulks and epoxy sealants.
Cost estimate: \$80

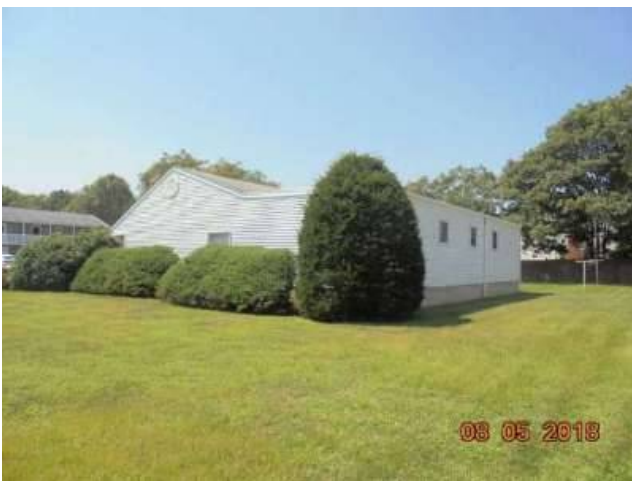
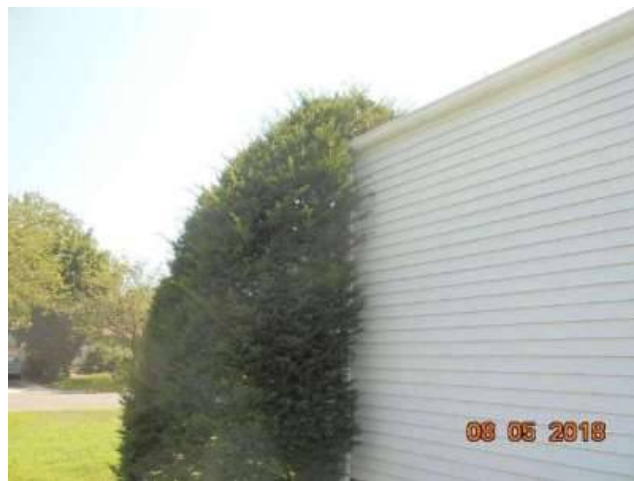
Vegetation such as trees, shrubs and/or vines was in contact with or close to the building exterior. Vegetation can serve as a pathway for wood-destroying insects and can retain moisture against the exterior after it rains. This is a conducive condition for wood-destroying organisms. Recommend pruning, moving or removing vegetation as necessary to maintain at least 6 inches of space between it and the building exterior. A 1-foot clearance is better.

Cost estimate: \$800

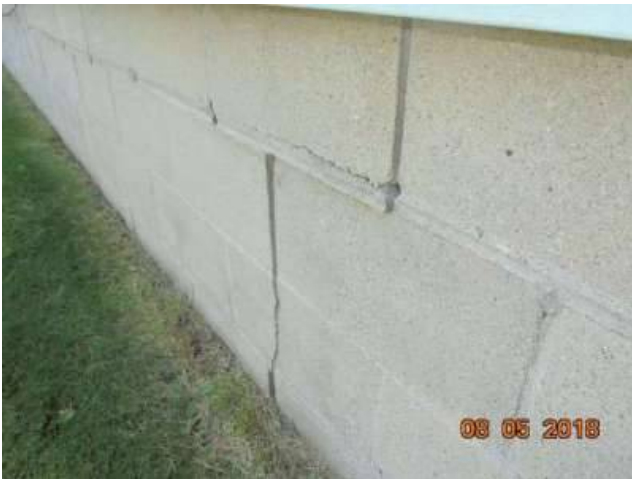
Photo 7-1

7) Moderate cracks (1/8 inch - 3/4 inch) and/or leaning were found in the cinder block wall behind the house, this wall is not part of the main foundation. This wall was built to enclose an 3' overhang on the original construction. This may be a structural concern or an indication that settlement is ongoing. The client should consider hiring a qualified contractors and/or engineers as necessary for further evaluation. Such contractors may include:

- Foundation repair contractors who may prescribe repairs, and will give cost estimates for such repairs
- Masonry contractors who repair and/or replace brick veneer
- Geotechnical engineers who attempt to determine if settlement is ongoing, and the cause of the settlement
- Structural engineers who determine if repairs are necessary, and prescribe those repairs

At a minimum, recommend sealing cracks to prevent water infiltration. Numerous products exist to seal such cracks including hydraulic cement, resilient caulks and epoxy sealants.

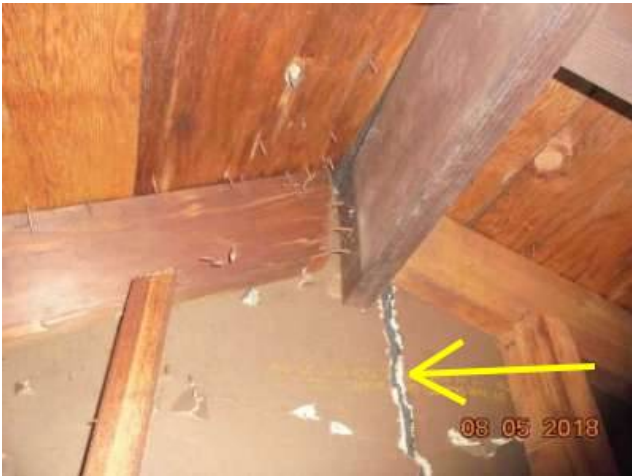
Photo 8-1

8) Sheetrock was noted in the attic being used on the exterior walls, this practice was used in the late 1950's. This is a structural concern due to the structure not having the same strength as plywood. The sheet-rock has failed/cracked due to the house shifting or settling. Consult with a qualified contractor for further evaluation.

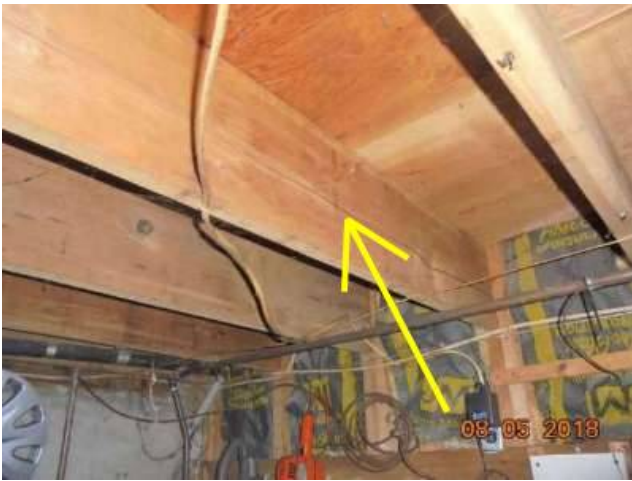
Photo 9-1

9) One split floor joist was noted in the basement, this is not a concern at this time.

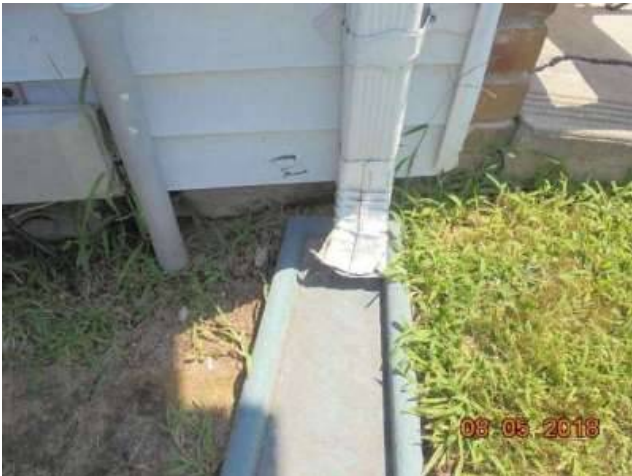
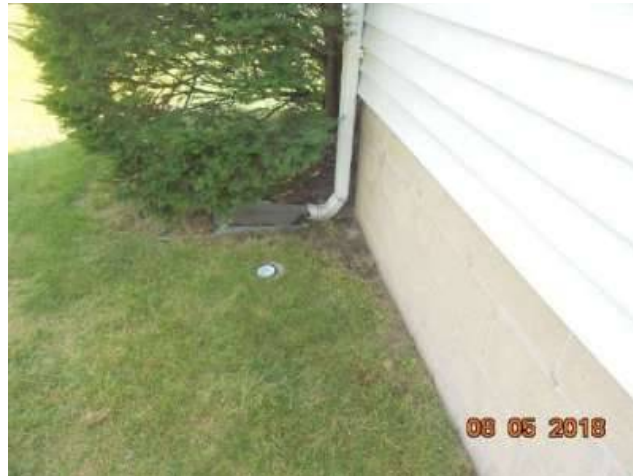
Extensions such as splash blocks or drain pipes for one or more downspouts were poorly sloped and/or substandard. Water can accumulate around the building foundation or inside crawl spaces or basements as a result. Recommend that a qualified person install, replace or repair extensions as necessary so rainwater drains away from the structure.

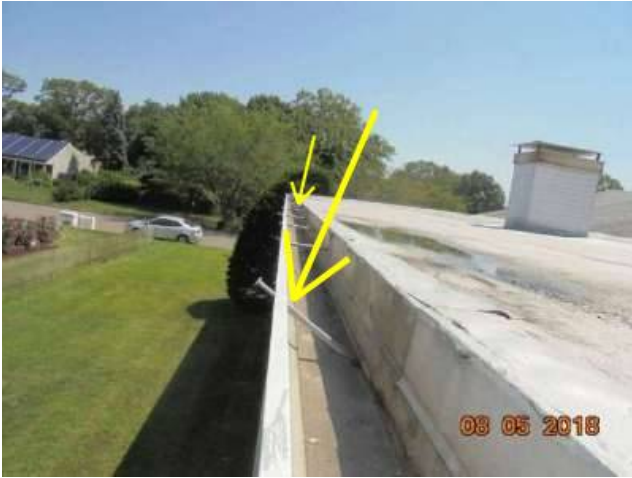
Photo 11-1

11) The rear gutter mounting spikes are coming loose, consult with contractor to repair the gutter as required.

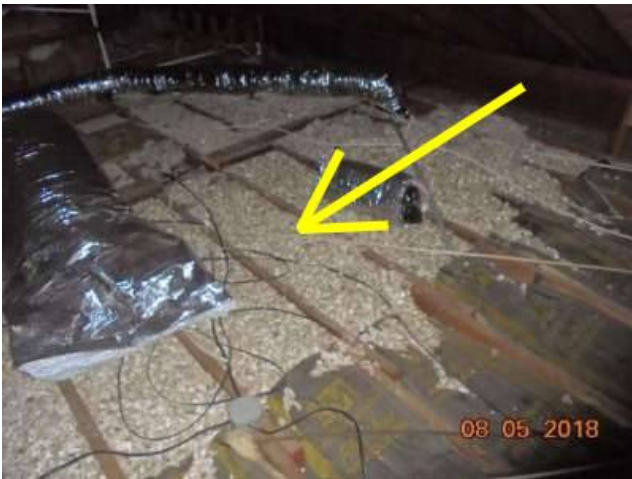
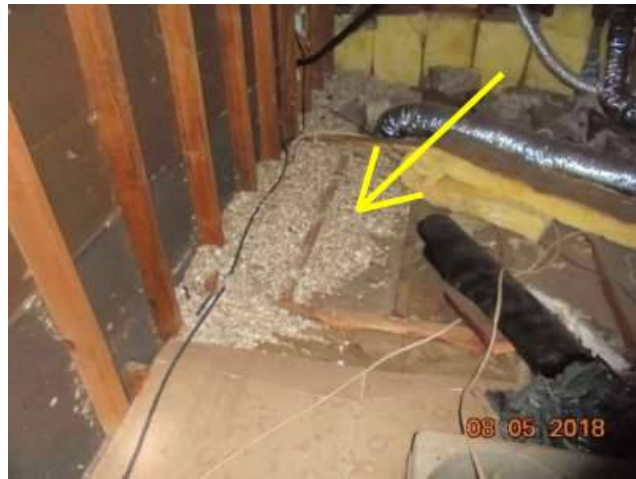
12) + i What appeared to be vermiculite insulation was found in the attic. Vermiculite produced prior to 1991 may contain asbestos, less so if mined after 1991. When vermiculite insulation is present in attics, the EPA recommends that it be left undisturbed and that the attic not be used for storage, and that people (especially children) should not enter the attic. If the client is concerned about this material posing a safety hazard, then consult with a qualified asbestos abatement specialist or industrial hygienist. For more information, visit:

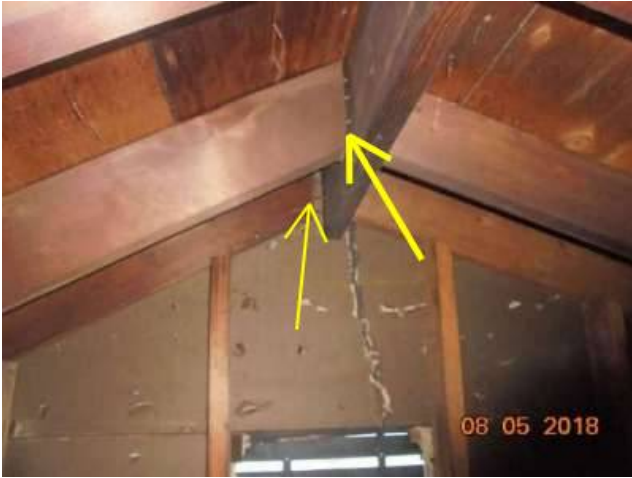
Photo 13-1

13) ⚠ Major Concern - Approximately three rafters in the roof structure were pulling away from the ridge beam, this may be due to the house settling and it may be related to the driveway sinking. This may significantly weaken the roof structure. Recommend that a qualified contractor repair as necessary.

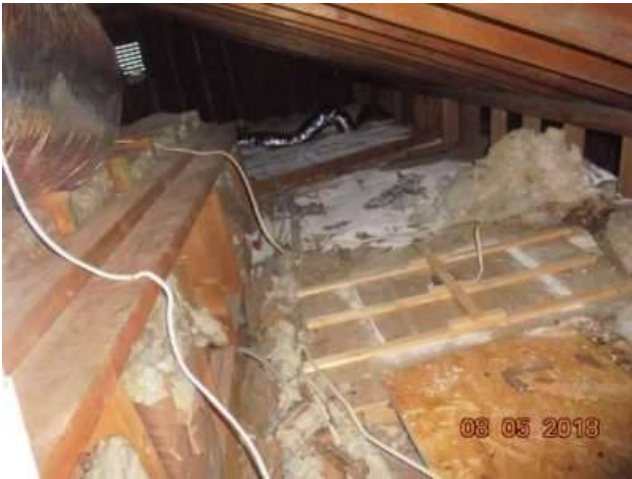
Photo 14-1

The ceiling insulation installed in the attic was substandard and appeared to have an R rating that's significantly less than current standards (R-38). Heating and cooling costs will likely be higher due to poor energy efficiency. Recommend that a qualified contractor install insulation for better energy efficiency and per standard building practices.

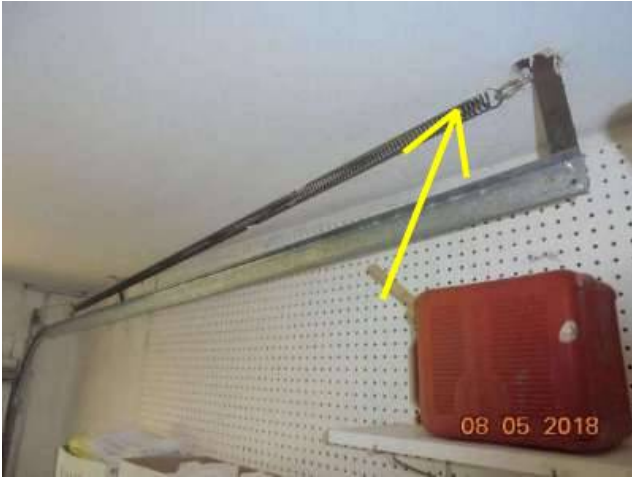
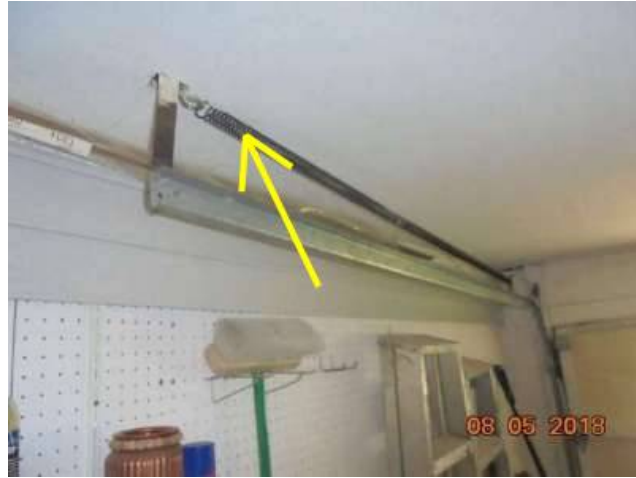
The two extension springs supporting garage vehicle doors had no safety containment cables installed. These cables prevent injury to people located nearby when springs eventually break. This is a potential safety hazard. Recommend that a qualified contractor install cables where missing per standard building practices. For more information, visit:

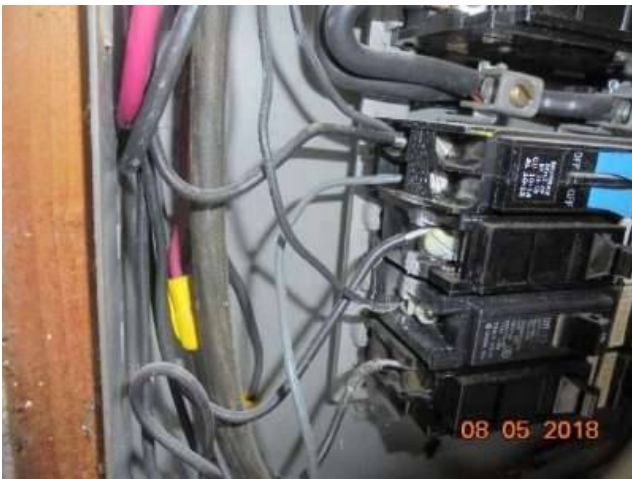
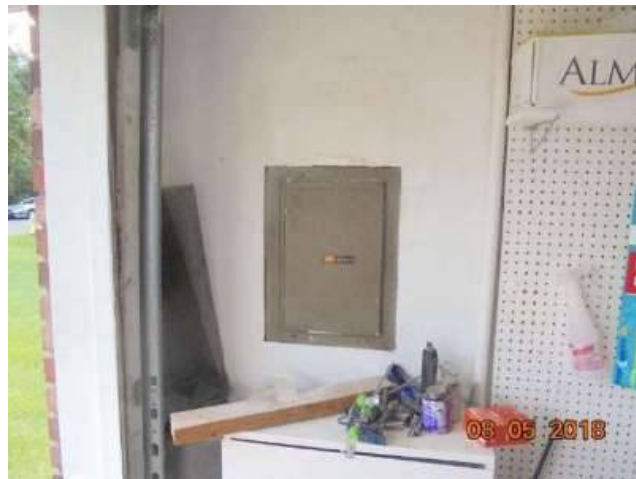
- 17) One or more branch circuits with solid-strand aluminum wires were found. Problems due to expansion and contraction with this type of wiring can cause overheating at connections between the wire and devices such as switches and receptacles, or at splices. This is a potential fire hazard. The Consumer Products Safety Commission recommends either discontinuing use of circuits with aluminum wiring, removing the wiring, or that an electrician determine if copper wire can be pig-tailed onto the ends of the aluminum wire. A qualified electrician should evaluate the full electrical system and repair as necessary. For more information, visit:

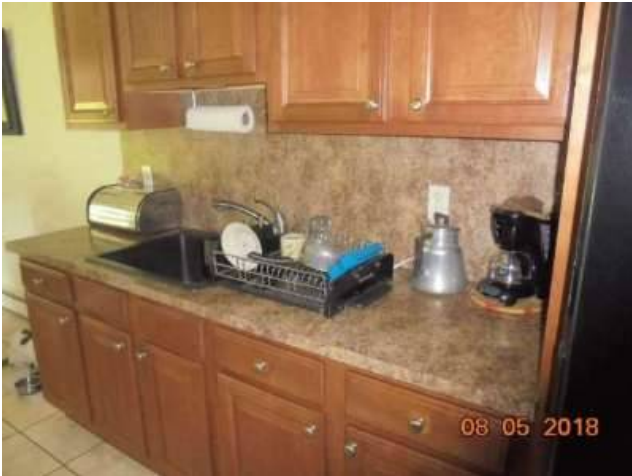
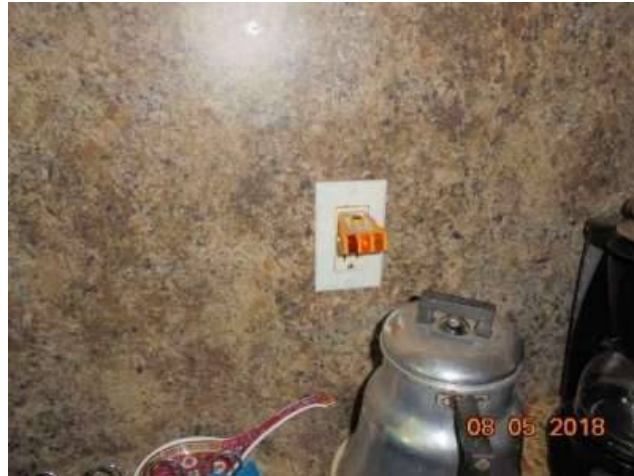
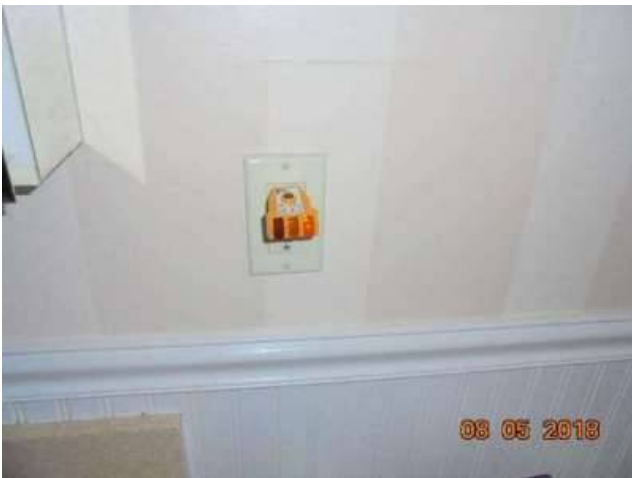
- 18) One or more electric receptacles at the kitchen and/or bathroom(s) had no visible ground fault circuit interrupter (GFCI) protection, or the

inspector was unable to determine if GFCI protection was present. If not GFCI-protected, receptacles in wet areas pose a shock hazard. Recommend that a qualified electrician evaluate and install GFCI protection if necessary and per standard building practices. General guidelines for GFCI-protected receptacles include the following locations:

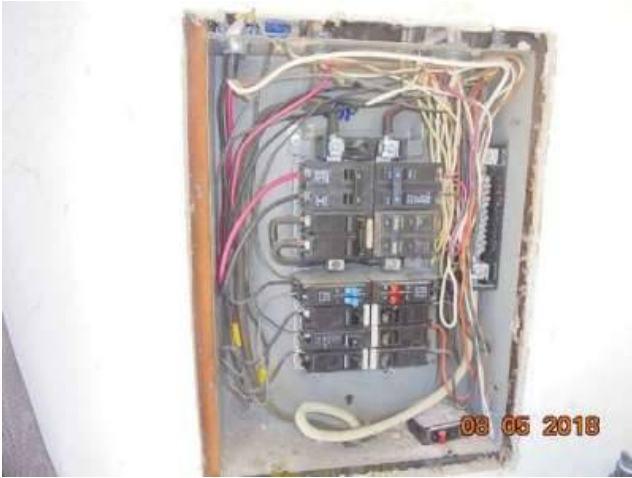
Photo 19-1

19) + The electric service was configured so that too many hand movements were necessary to turn off all power for the service. Six or fewer circuit breakers should be required to turn off all power to a residence. This is a potential safety hazard during an emergency when the power needs to be turned off quickly. Recommend that a qualified electrician repair per standard building practices.

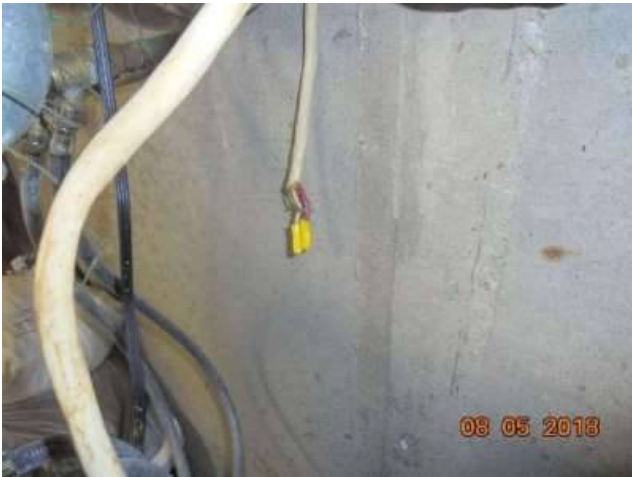
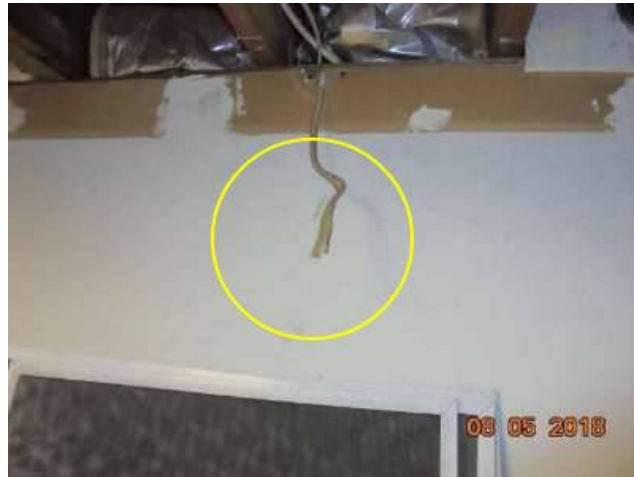
Bare wire ends, or wires with a substandard termination, were found in the basement. This is a potential shock hazard. Recommend that a qualified electrician repair as necessary. For example, by cutting wires to length and terminating with wire nuts in a permanently mounted, covered junction box.

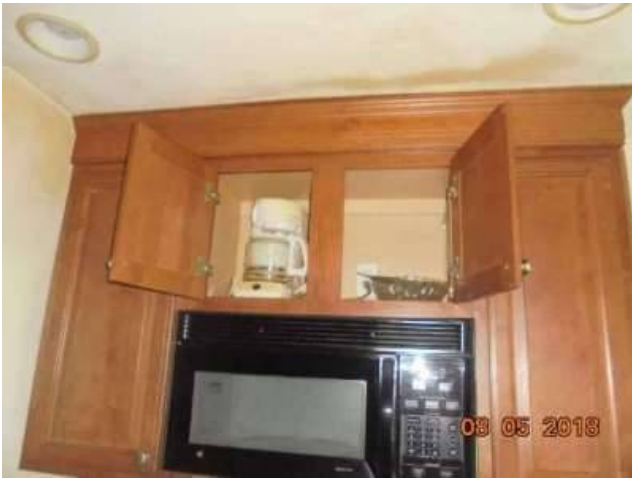
Photo 26-1

No exhaust hood, ceiling or wall-mounted exhaust fan or downdraft exhaust system was found for the cook top or range. This can be a nuisance for odor and grease accumulation. Where a gas-fired range or cook top is installed, carbon monoxide and excessive levels of moisture can accumulate in living spaces. Recommend that a qualified contractor install a venting system per standard building practices.
Cost estimate: \$1,500

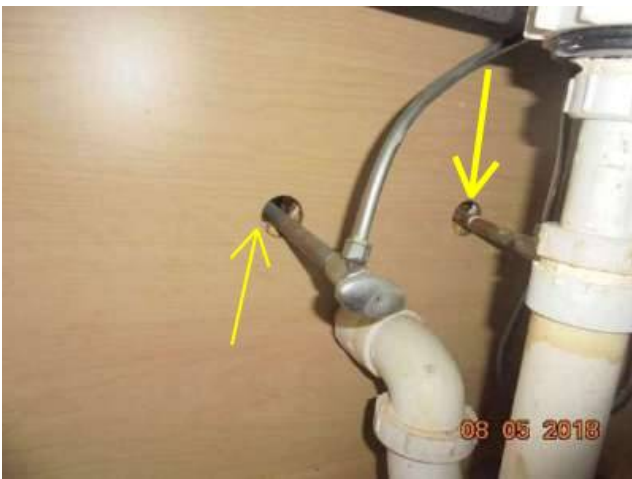
Photo 27-1

27) Open bypasses were noted under the kitchen sink, these should be sealed with insulation to prevent vermin or loss of heat in the winter.
Cost estimate: \$60

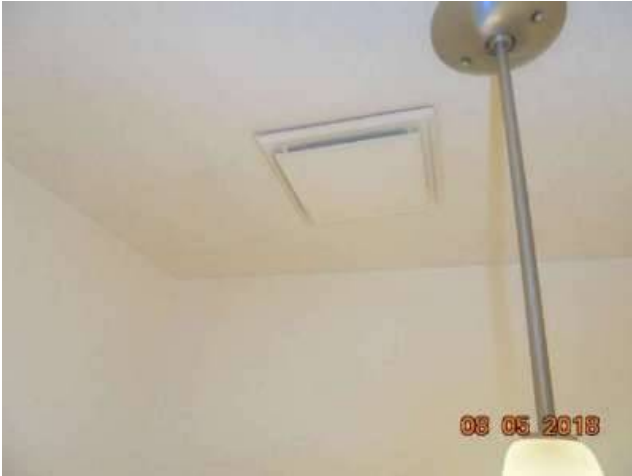
Photo 28-1

The exhaust fan in second floor was inoperable. Moisture may accumulate and result in mold, bacteria or fungal growth. Recommend that a qualified person clean, repair or replace fans as necessary.

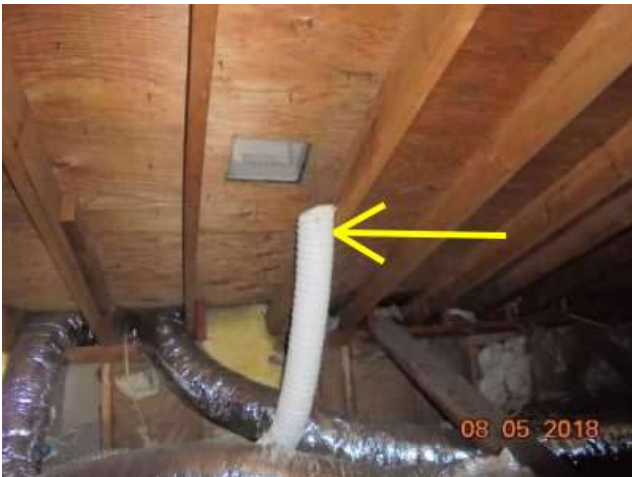
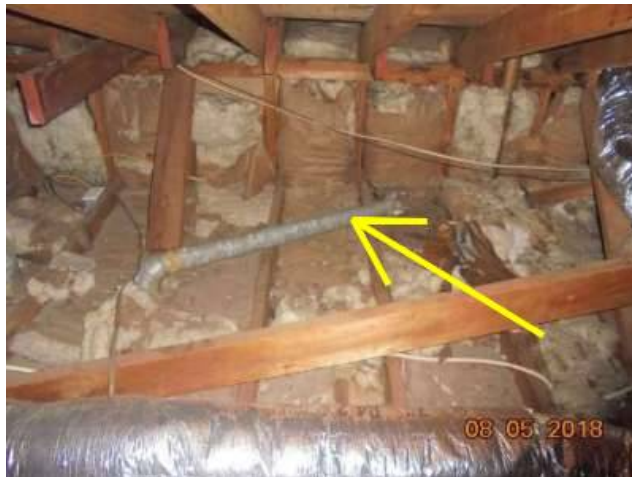
29) The bathroom exhaust duct terminated in the attic space area. Moisture may accumulate and result in mold, bacteria or fungal growth. Recommend that a qualified person install, repair or replace the duct as necessary so it terminates outdoors, and per standard building practices.

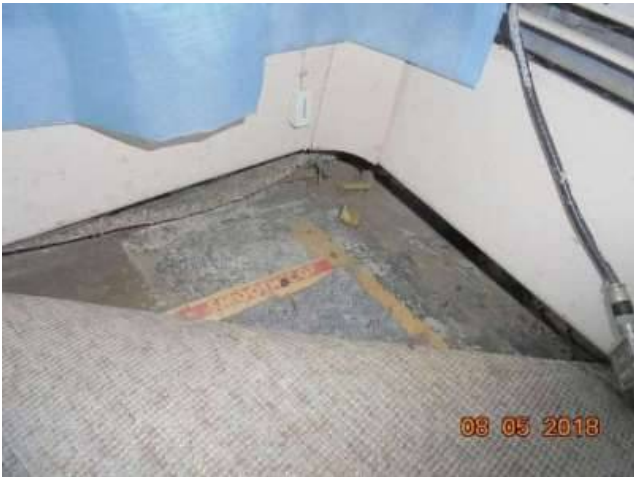
Photo 30-1

Significant settlement was found in the south west corner sections of concrete slab floors. Recommend that a qualified contractor repair or replace concrete slab floors where necessary.

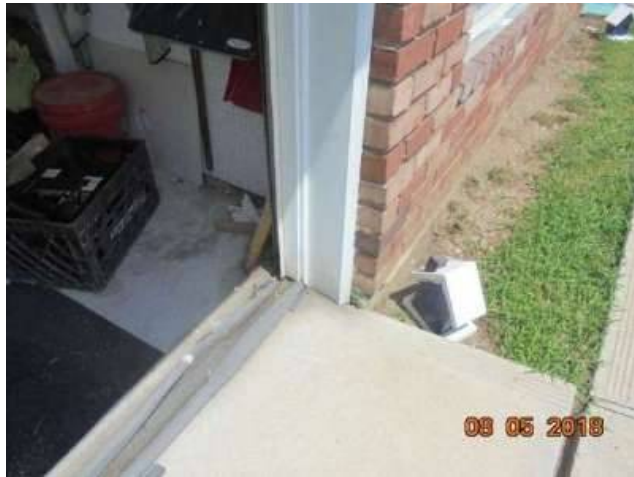
Photo 30-2 No damage noted on the exterior

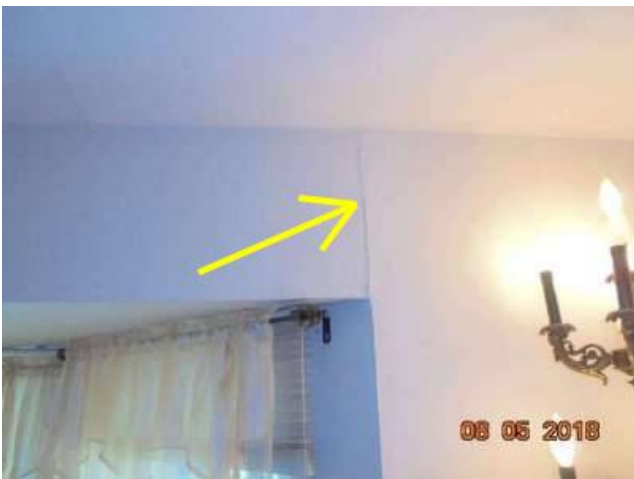
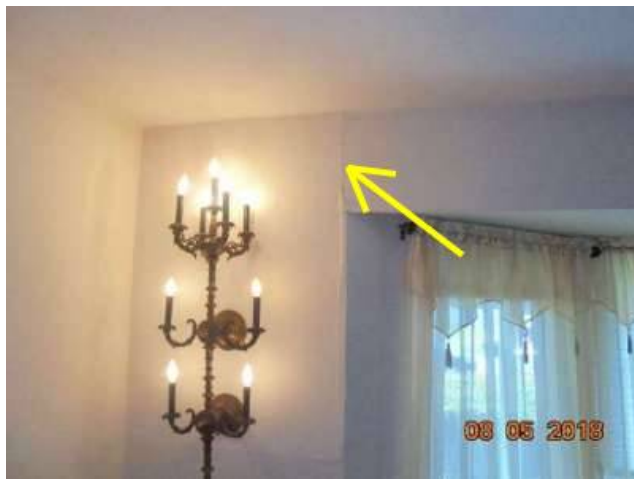
Minor cracks were found in walls and/or ceilings in one or more areas. Cracks and nail pops are common, are often caused by lumber shrinkage or minor settlement, and can be more or less noticeable depending on changes in humidity. They did not appear to be a structural concern, but the client may wish to repair these for aesthetic reasons. For recurring cracks, consider using an elastic crack covering product:

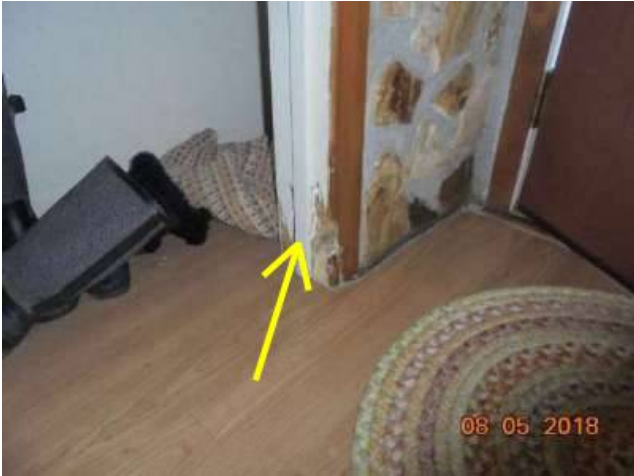
Photo 33-1

Evidence of past infestation of subterranean termites was found in the coat closet by the front door in the form of with visible wood damage. Recommend the following:

- Correct any conducive conditions for wood-destroying organisms mentioned in this report.
- Consult with the property owner about any history of infestation.
- Have a state-licensed pest control operator evaluate further and treat as necessary.

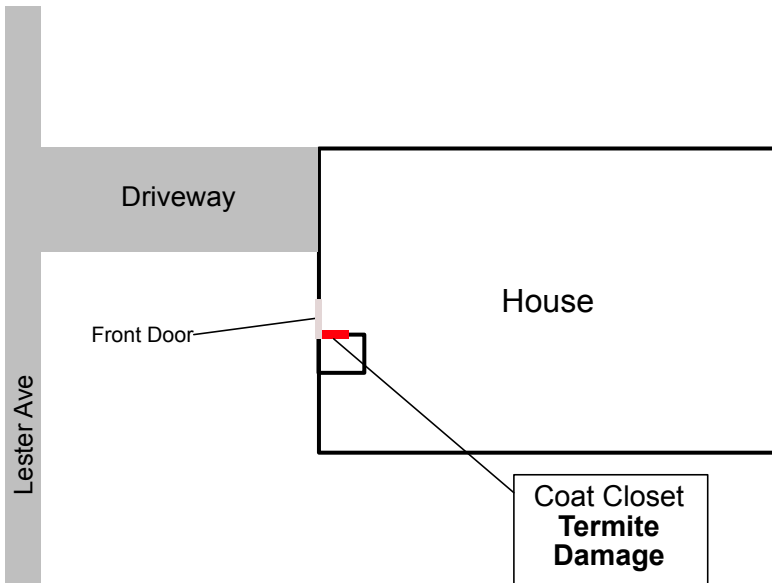
THE DOOR FRAME IN THE COAT CLOSE WAS OBSERVED TO HAVE TERMITE DAMAGE - SEE SKETCH FOR DETAILS.

NOTE: Additional damage or active termite may be uncover not noted due to inaccessible areas at the time of the inspection.
